TEST REPORT

TEST REPORT NO.: R13G22

Identification of Test Item: **Q13G53 – Fully Insulated Single-acting, Unequal Double-leaf Composite Timber Doorset**

Test Method: Fire resistance test conducted in accordance with BS EN 1634-1: 2008

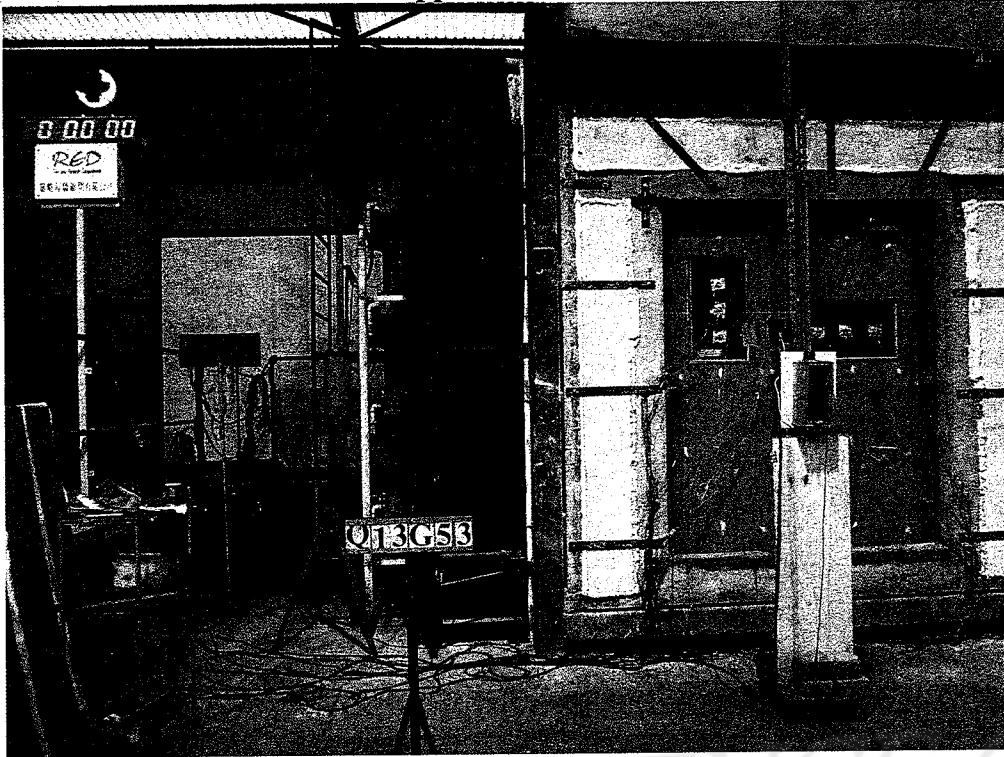
Photo 1: The unexposed face of the specimen before the test.

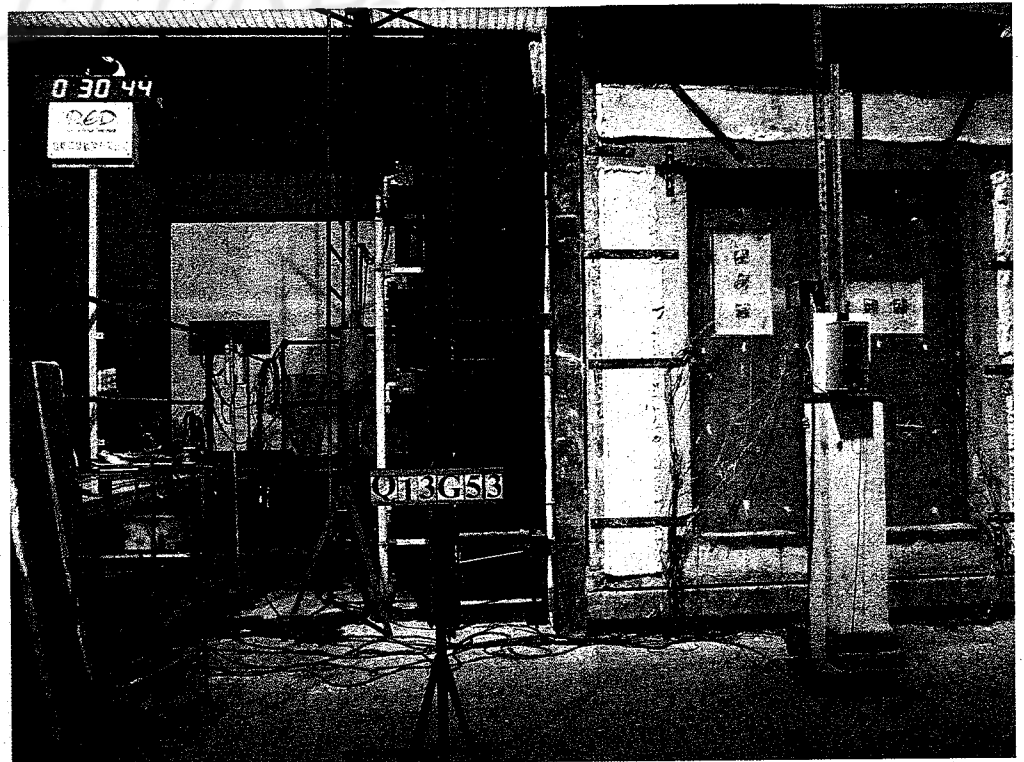
Photo 2: The unexposed face of the specimen after a heating period of 30 minutes.

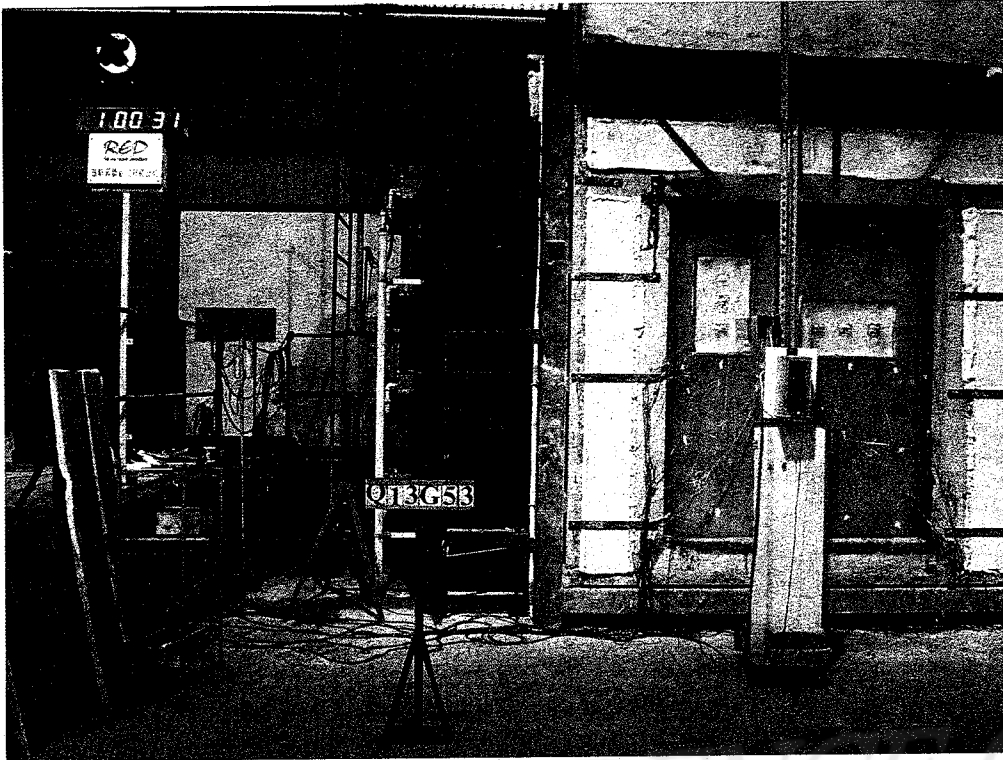
Photo 3: The unexposed face of the specimen after a heating period of 60 minutes.

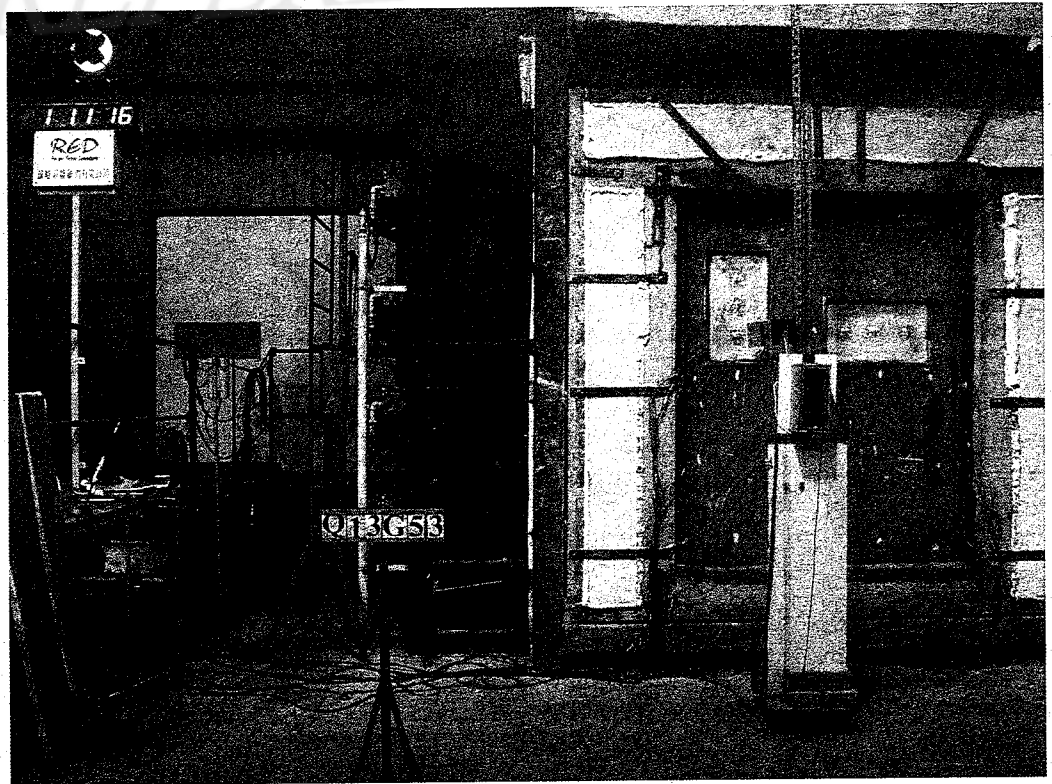
Photo 4: The unexposed face of the specimen after the test.

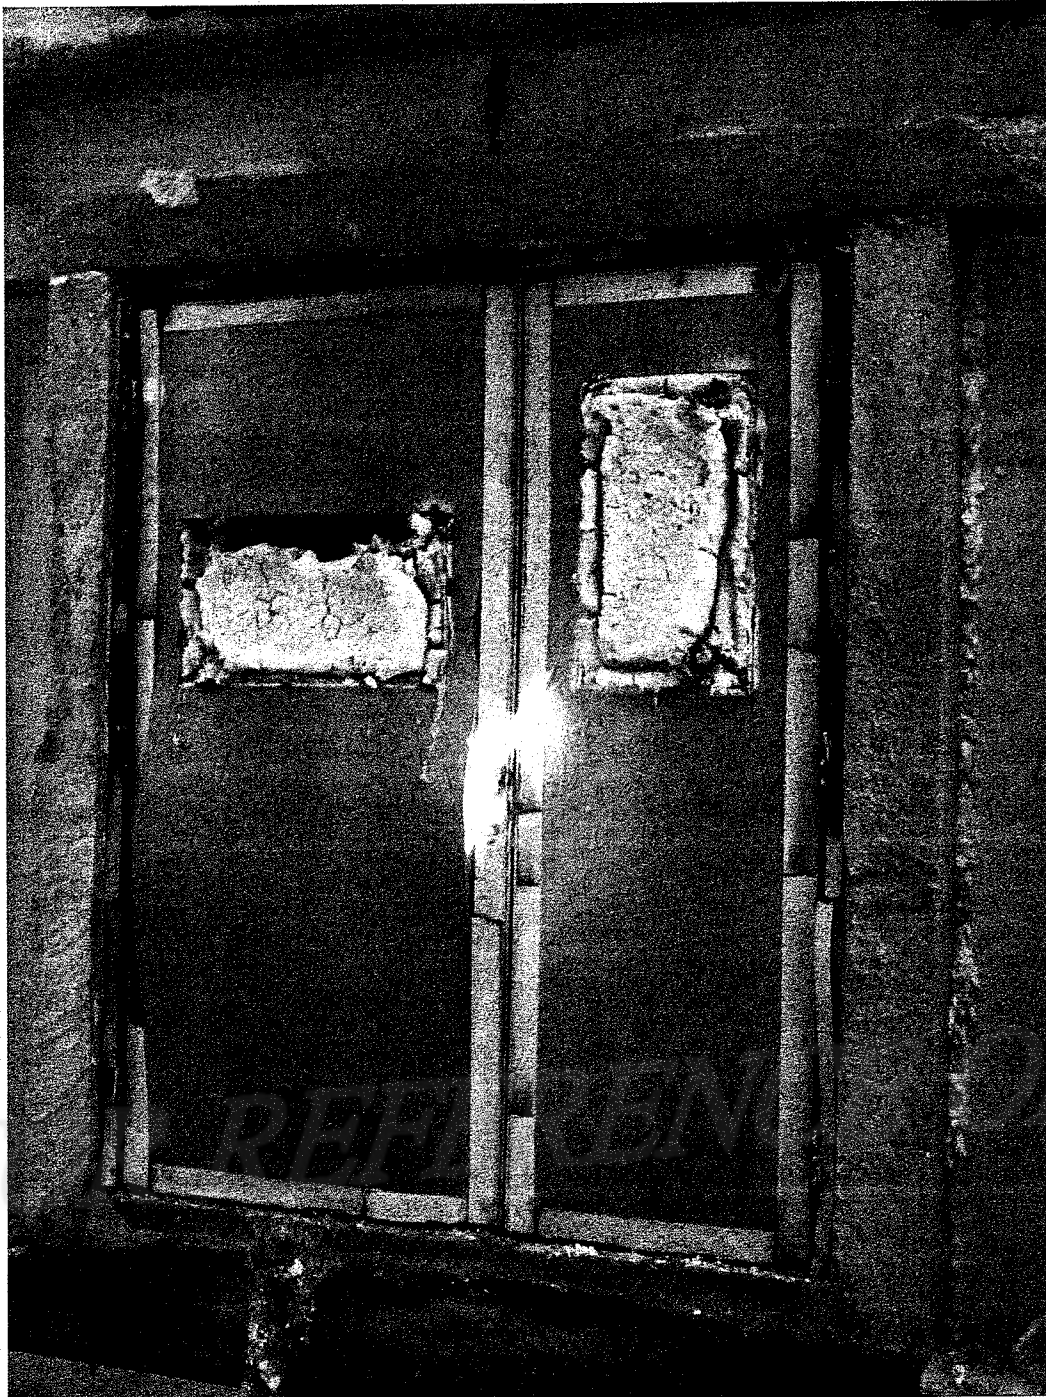
Photo 5: The exposed surface of specimen after the test.

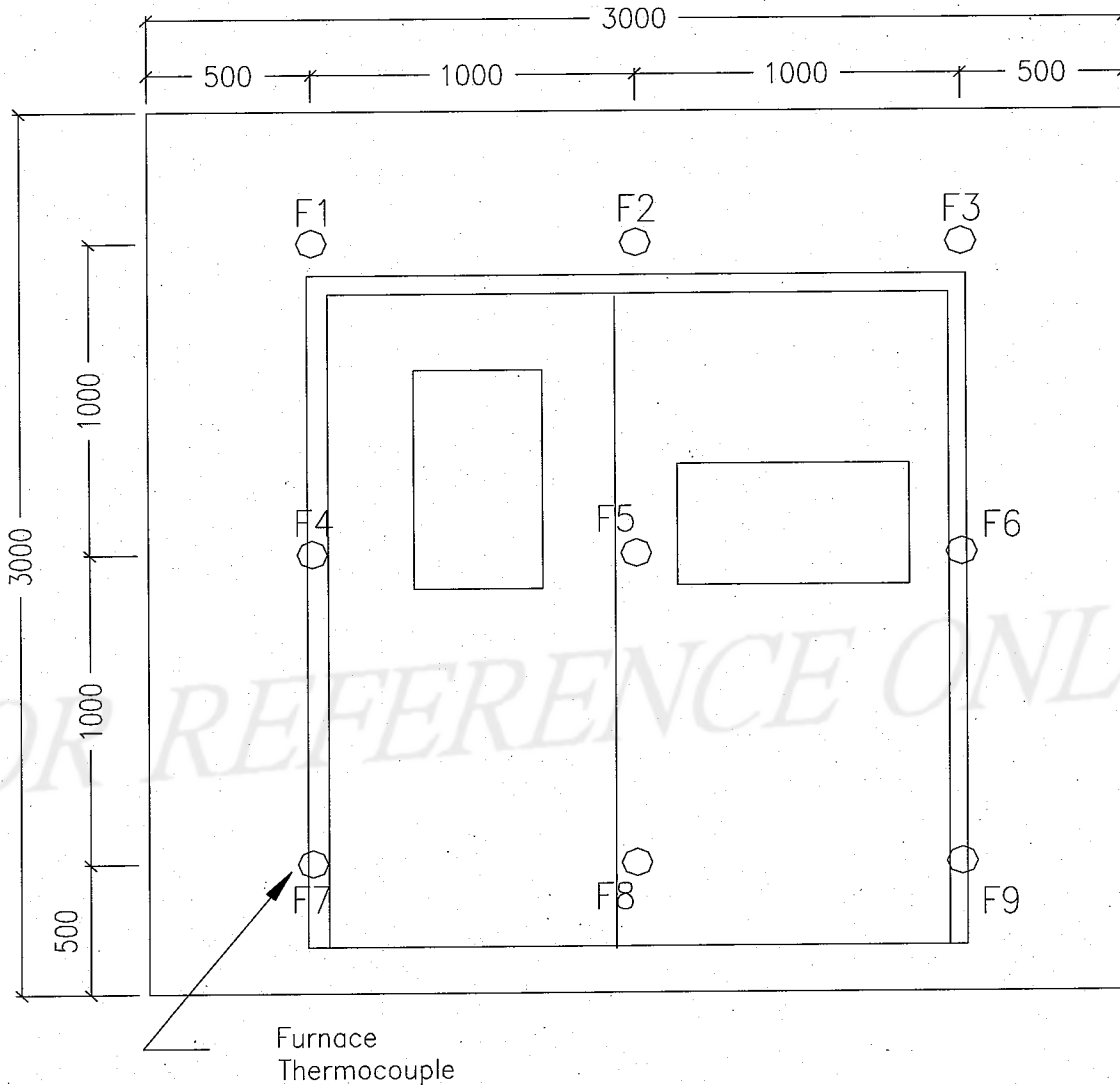
Figure 1 – Locations and reference numbers of furnace thermocouples.
(This figure is not to scale and all dimensions measured in millimetre.)

Nine (9) 'type K' thermocouples to monitor the temperature of the furnace, which were kept at 100 mm from the exposed face of the specimen (see Figure 1).

Notes: Locations of furnace thermocouples are shown in Figure 1.

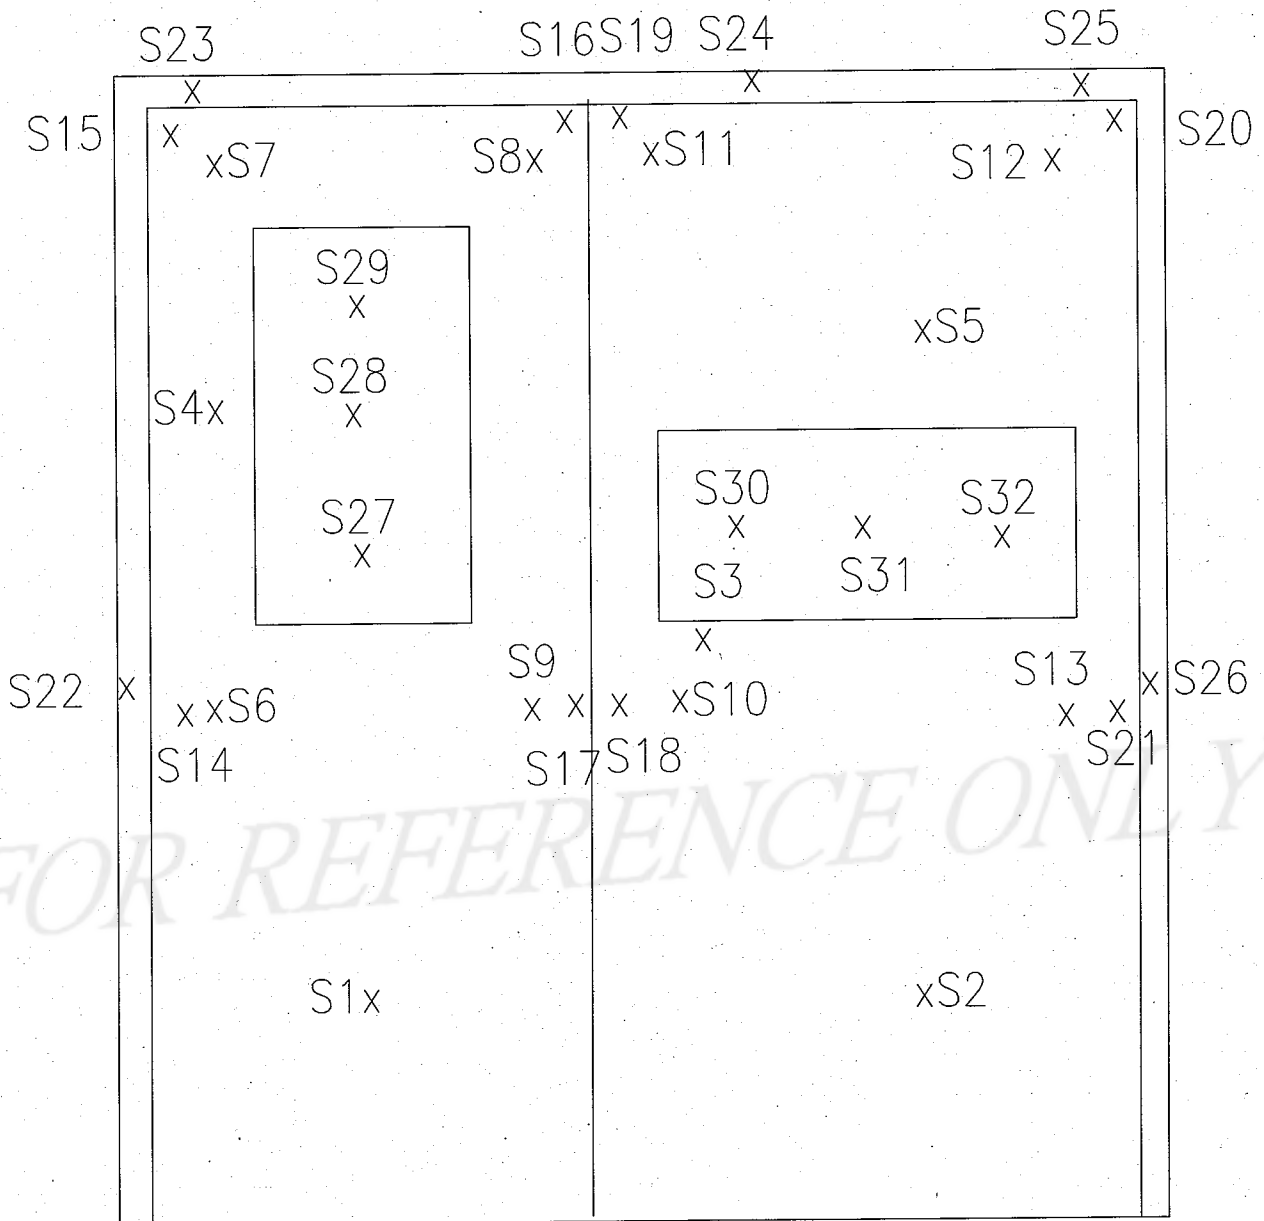
Figure 2 – Locations and reference numbers of thermocouples to monitor the temperature of unexposed surface of the specimen.
(This figure is not to scale.)

Thirty-two (32) 'type K' thermocouples to monitor the temperature of the unexposed face of the specimen (see Figure 2).

The temperature of the unexposed face was monitored by means of thirty-two (32) thermocouples fixed to the unexposed surface (see Figure 2 for the locations and reference numbers of the thermocouples). Five of them (S1 – S5) were fixed on the door leaves for mean and maximum temperatures of the unexposed surface of door leaves. Thermocouples S6 – S26 were fixed on the door leaves and door frame for maximum temperature of the unexposed surface of doorset. Thermocouples S27 – S32 were fixed on the glazed panels for mean and maximum temperature of the unexposed surface of glazed panels. The mean and maximum temperatures were recorded.

Notes: Locations of thermocouples S1 – S16 are shown in Figure 2.

Notes: Locations of thermocouples S17 – S32 are shown in Figure 2.

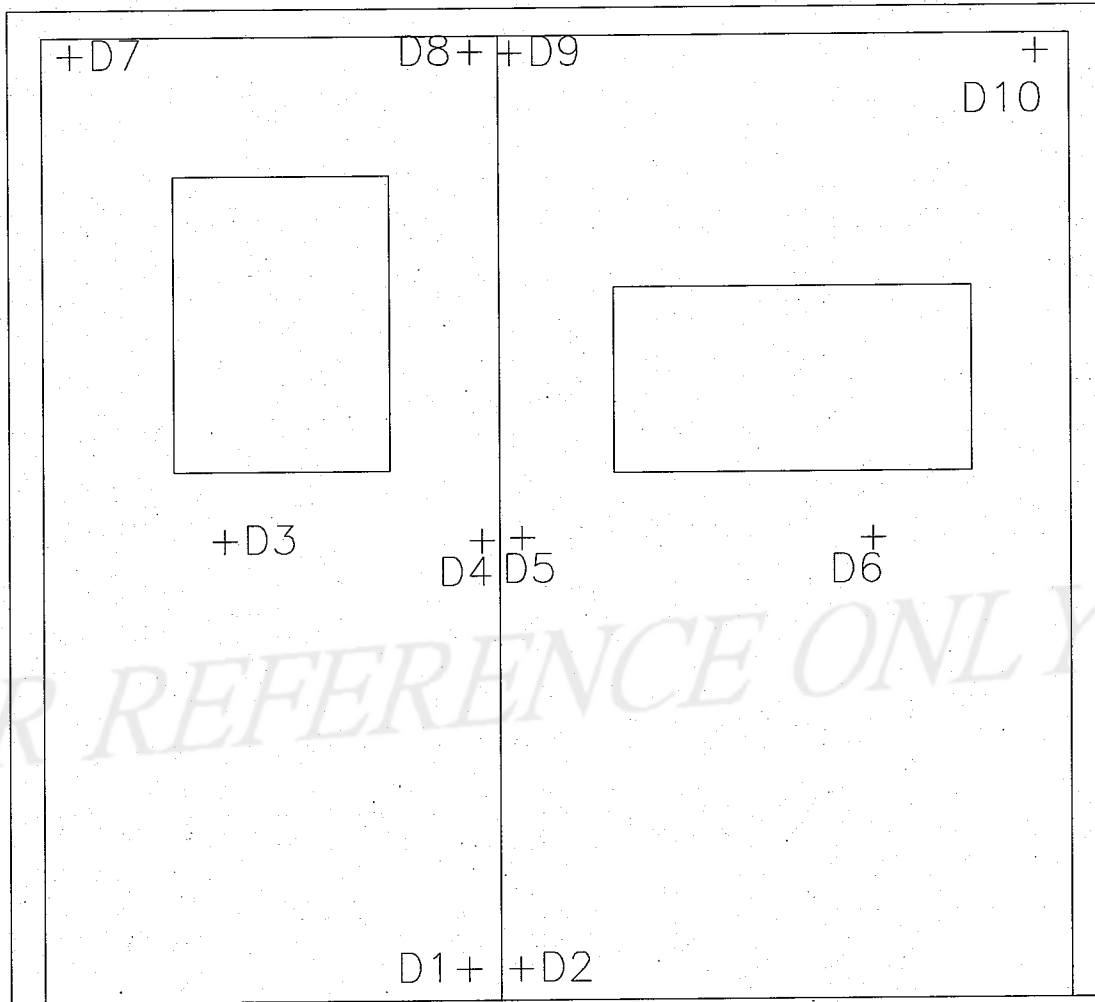
Figure 3 – Locations and reference numbers of displacement measurement.
(This figure is not to scale.)

Positive deflection indicates movement towards the furnace (see also Figure 3 for the locations). The maximum deflection of the specimen occurred at location D6 was 35 mm moving towards the furnace after a heating period of 60 minutes.

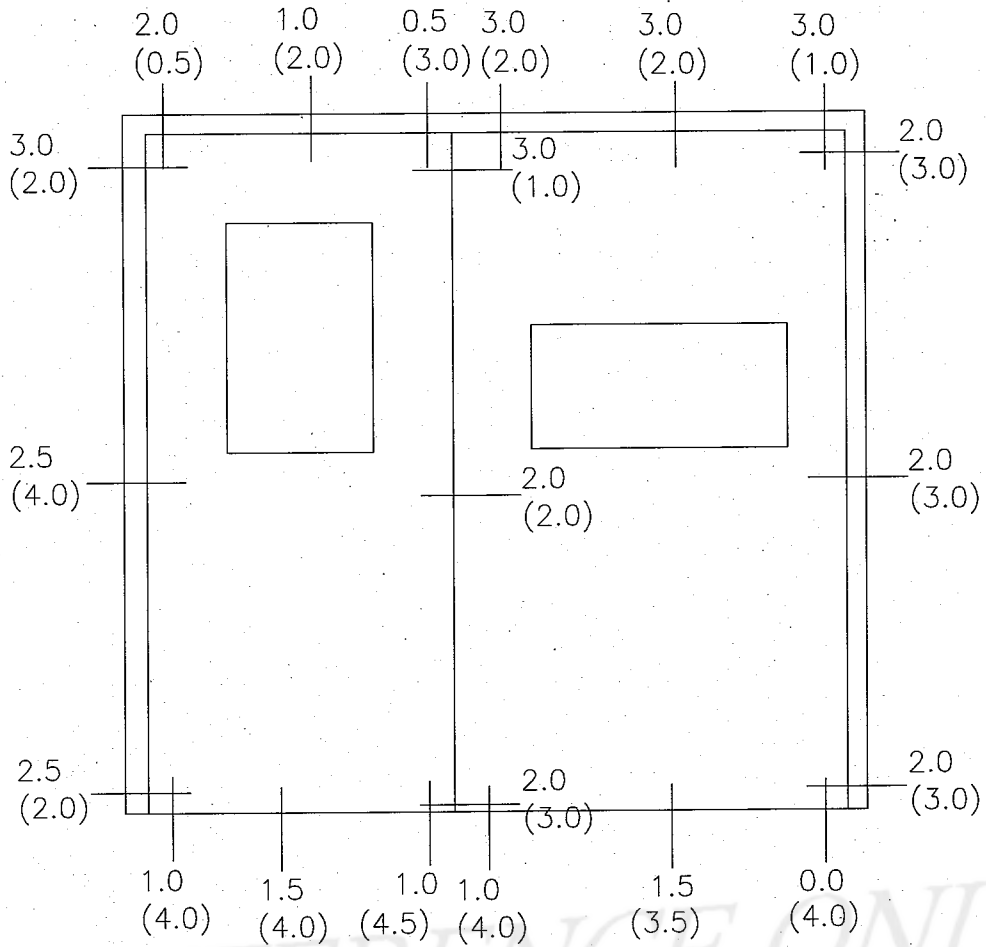
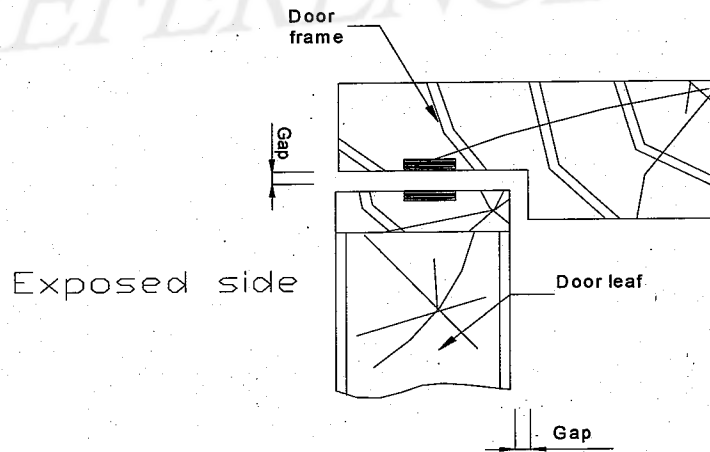
Figure 4 – Door gaps in mm, measured from unexposed face.
(Measurements from exposed face are in brackets)
(This figure is not to scale.)

The manufacturer did not declare a working range so the doorset was installed to open and close freely, maintaining gaps, where possible, to a range of 0.5 – 4.0 mm. The gaps between the edge of the door leaf/leaves and frame(s) were measured prior to test. The measurements (in mm) are given in Figure 4.

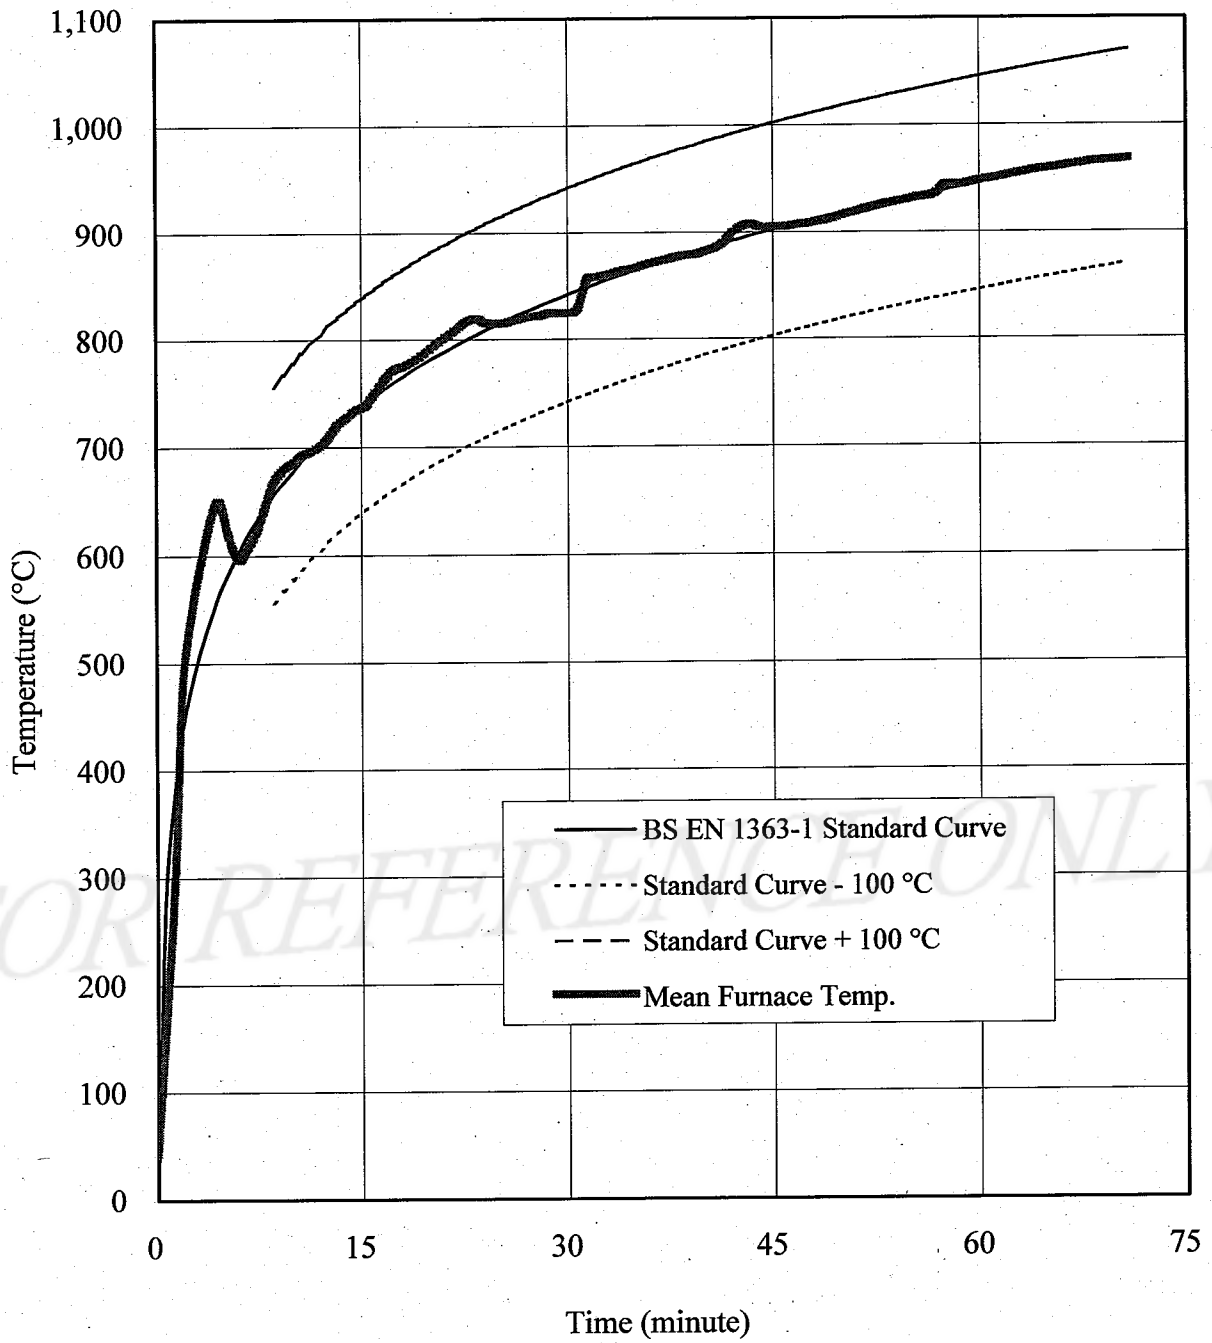
Figure 5 – Mean furnace temperature.

The furnace was controlled so that the mean furnace temperature complied with the requirements of Clause 4.5.1.1 of BS EN 1363-1: 1999. The temperatures recorded are shown graphically in Figure 5.

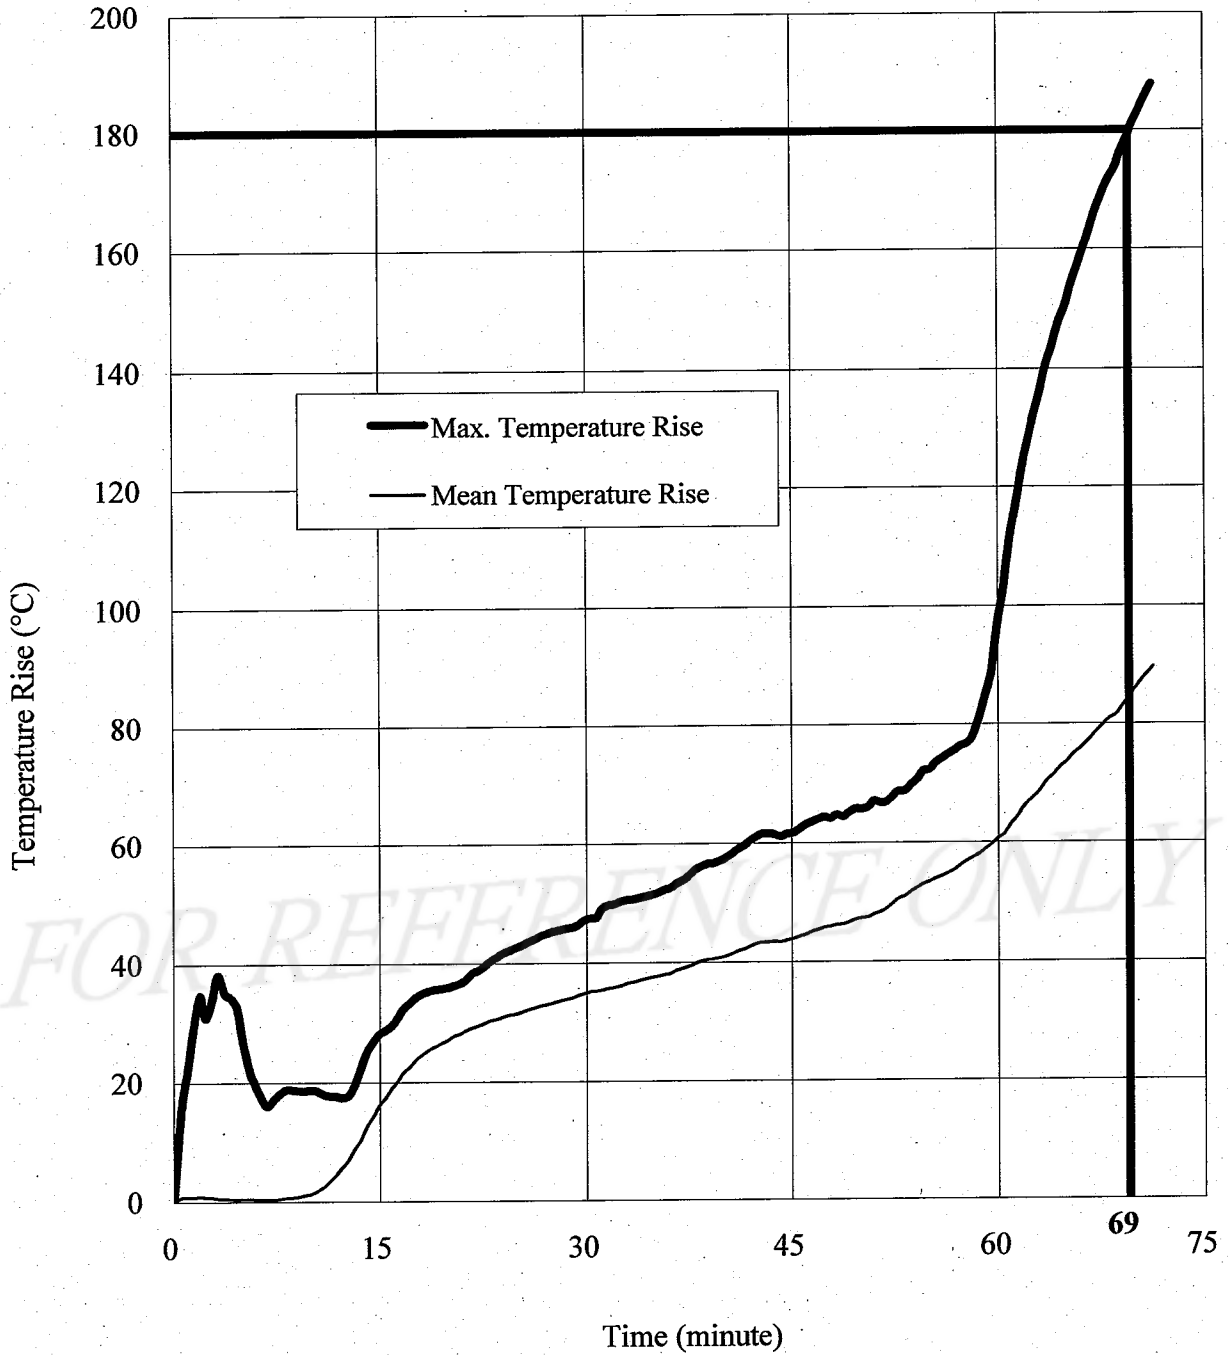
Figure 6 – Temperature rises of unexposed surface of doorset excluding the glazed panels.

The mean and maximum temperatures of the unexposed surface of the doorset excluding the glazed panels are shown graphically in Figure 6.

The 140 °C rise of the mean temperature of the unexposed surface of specimen did not reach during the test. The 180 °C rise of the maximum temperature of the unexposed surface of specimen reached and measured by thermocouple S13 after a heating period of 69 minutes. The maximum temperature rise was 188 °C measured by thermocouple S13 after a heating period of 71 minutes.

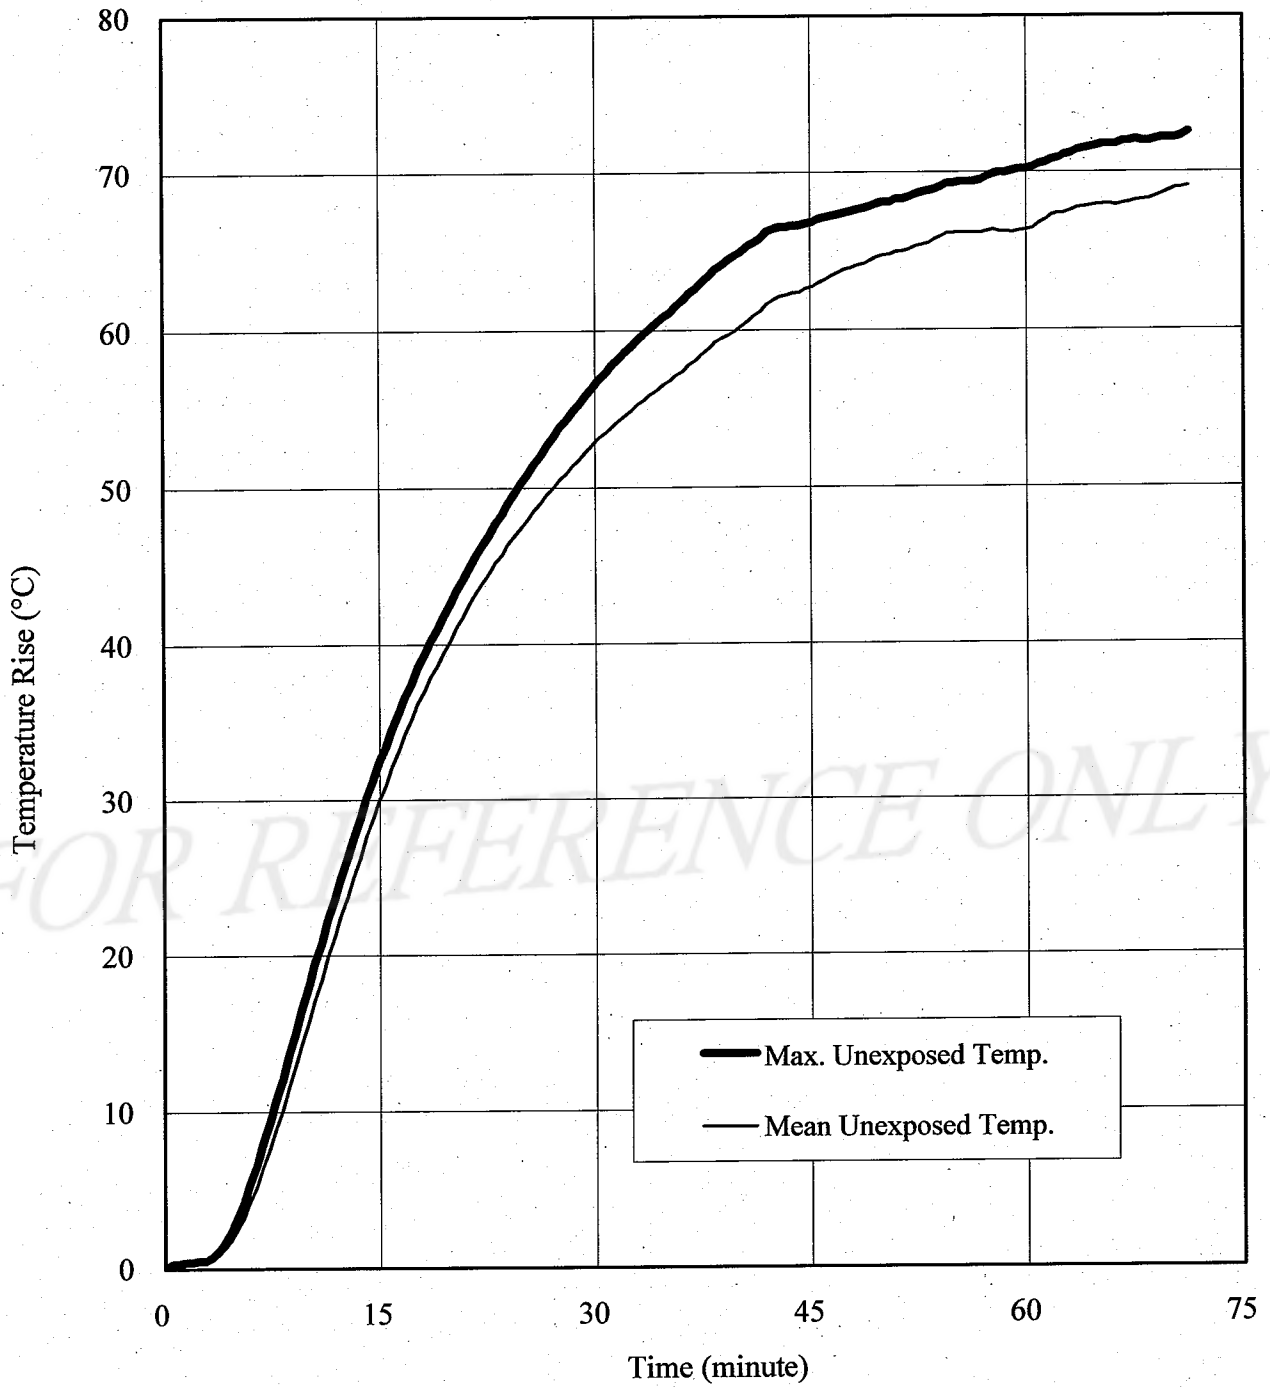
Figure 7 – Temperature rises of unexposed surface of the glazed panels.

The mean and maximum temperatures of the unexposed surface of the glazed panels are shown graphically in Figure 7.

The 140 °C rise of the mean temperature of the unexposed surface of glazed panels did not reach during the test. The 180 °C rise of the maximum temperature of the unexposed surface of specimen did not reach during the test. The maximum temperature rise was 73 °C measured by thermocouple S32 after a heating period of 71 minutes.

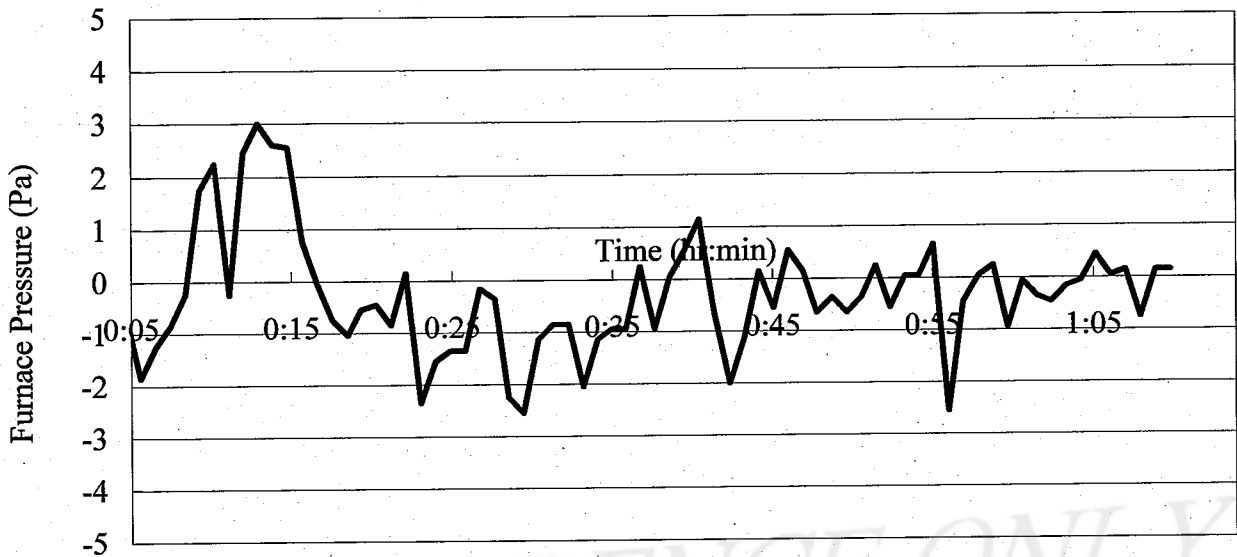
After the first 5 minutes of the test, the furnace pressure was maintained at 0 ± 3 Pa relative to atmosphere, at 500 mm from the notional floor level.

Figure 8 – Furnace pressure.

The furnace pressure is shown graphically in Figure 8.

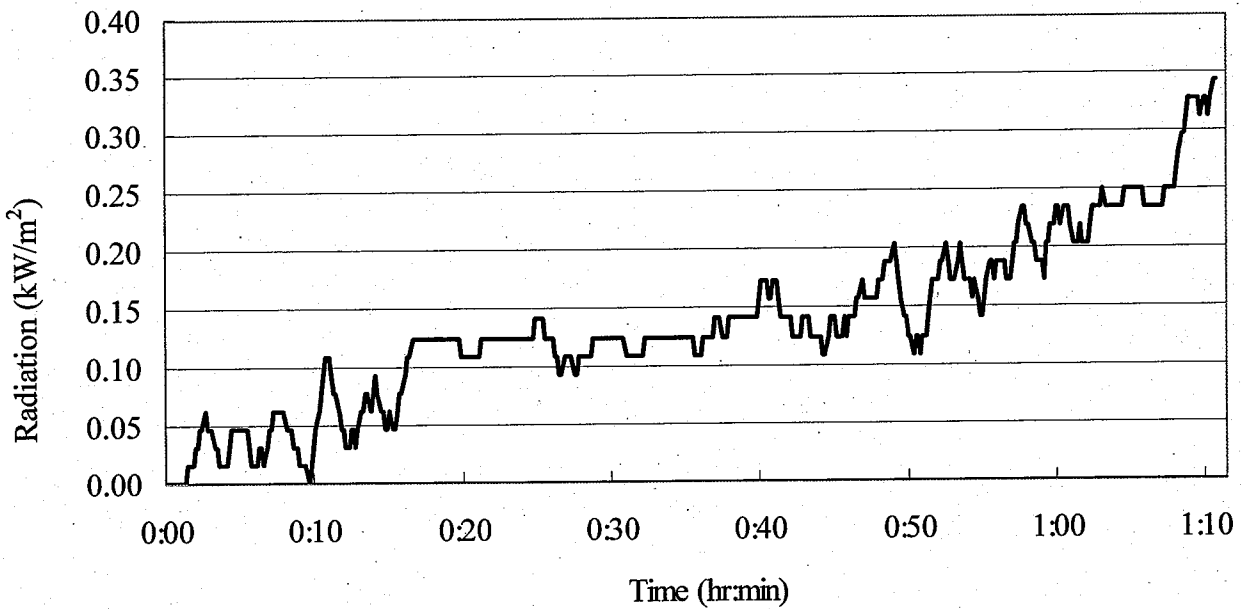
A radiometer placed at 1,000 mm away from the unexposed surface of specimen to measure the radiation of unexposed surface of the specimen.

Figure 9 – Radiation.

The radiation is shown graphically in Figure 9.

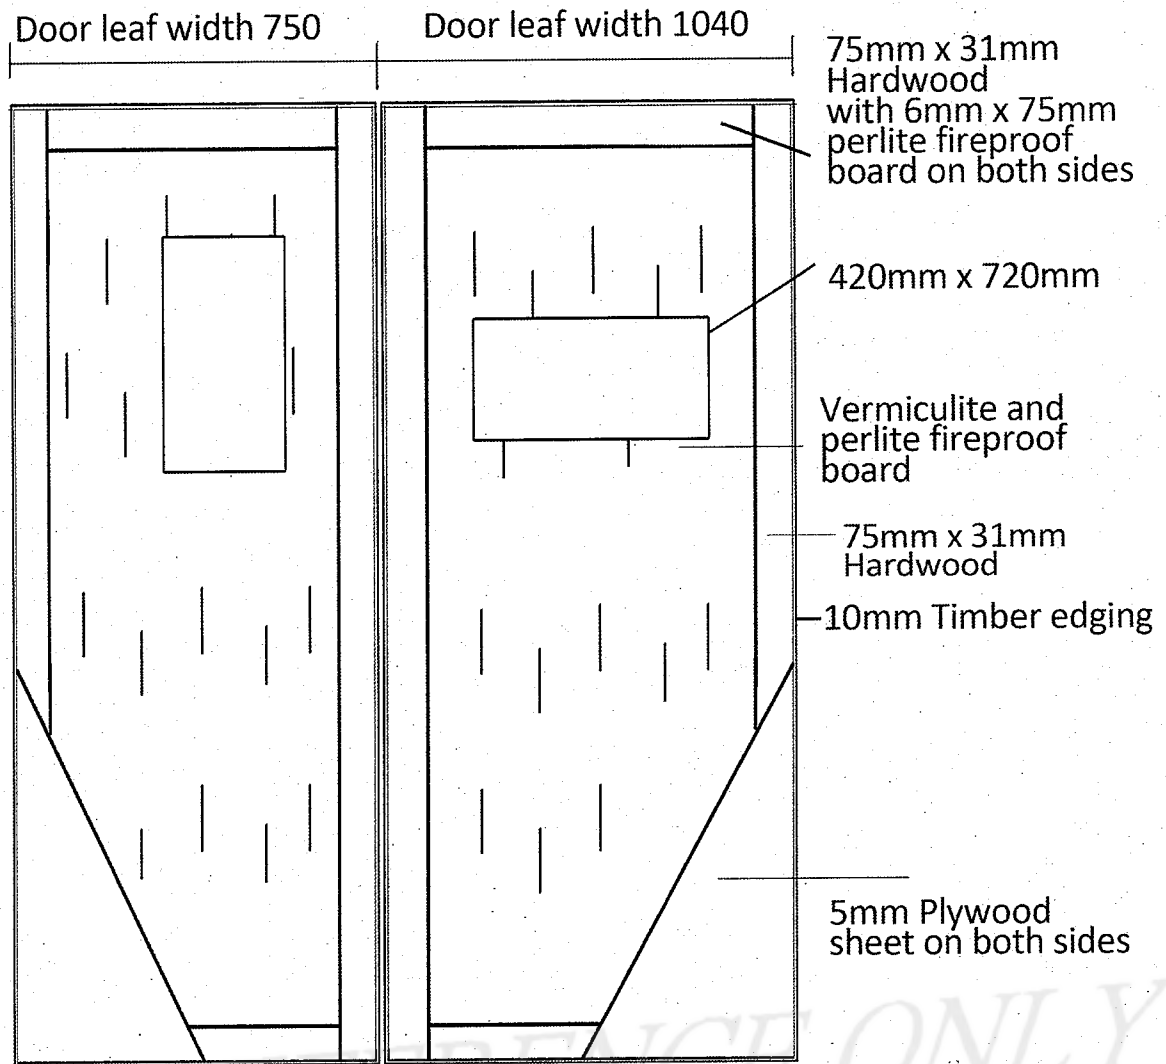
Pull Side Elevation

Door Leaf Construction

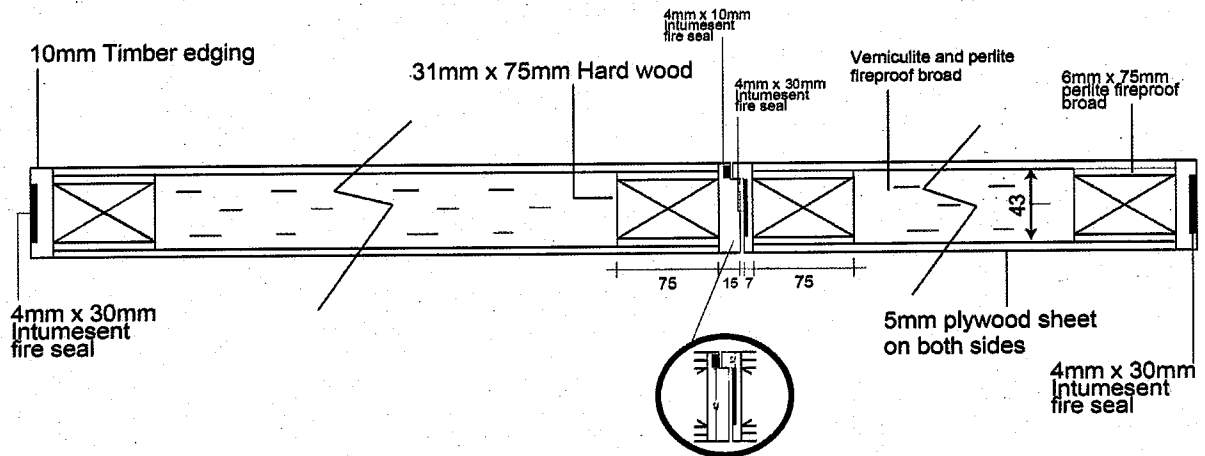
Meeting Stile

Smoke seal
